Roller Rubber Replacement for ATARI® 1027 Printers

Manual

REVIVE1027

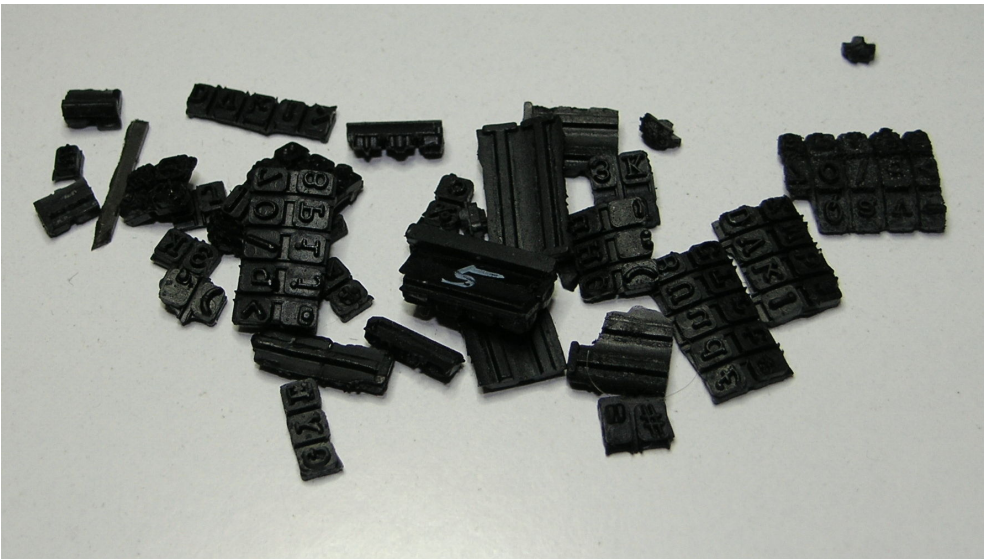
Typical 1027 rubber debris

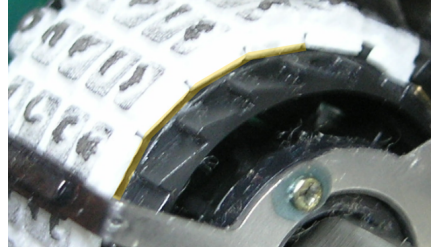
If the print shows many streaks and shadows, please press the rubber everywhere around firmly to the drum so that the part fits into the longitudinal ribs!
